OUTBUILDINGS AT HULLETT'S FARM, PILGRIMS HATCH, BRENTWOOD

WORKS REQUIRED TO HISTORIC BUILDINGS

ALAN STONES AADip TPDip IHBC ret

March 2016

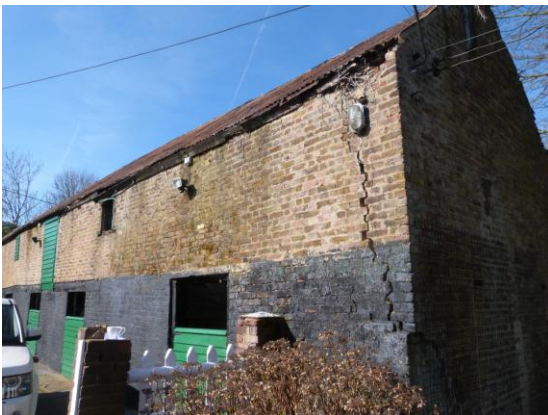
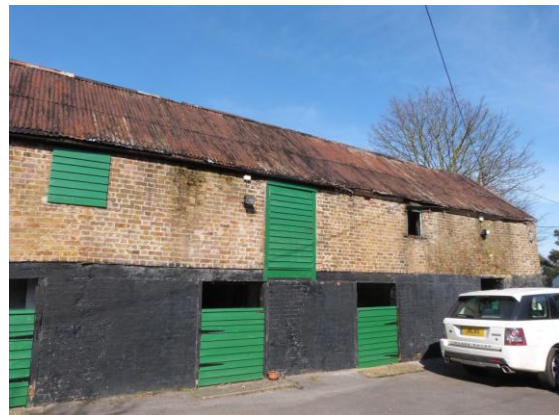
Subsidence has occurred at both ends of the building. At the east end the sagging of the longitudinal walls has caused a fracture with the gable end which is particularly severe on the south-east corner. The sagging longitudinal walls need to be underpinned and the fractured brickwork repaired.

Whilst underpinning, the opportunity should be taken of lowering the ground floor to increase the headroom of the lower storey. As the ground floor will then be below external ground level, tanking, damp-proof membrane and floor insulation should be carried out to facilitate future conversion to residential or commercial use.

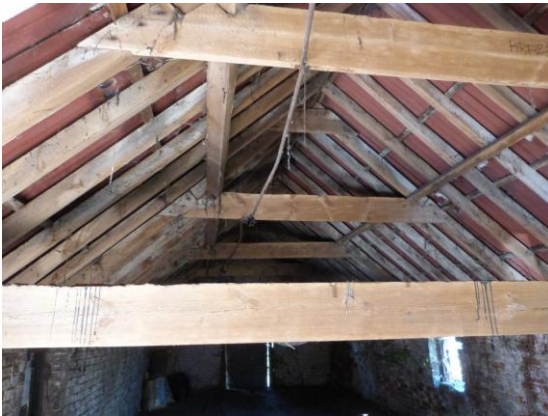
The roof structure consists of rafters tied at intervals by A-frame collars above head height. However, a number of substantial tie beams have been inserted at eaves level to reduce thrust on to the external walls, and these are below head height. For the space to be usable, these will have to be either incorporated in partitions or replaced by more frequent collars to prevent outward thrust from the rafters.

Floorboards are in poor condition, but the floor joists appear largely sound. The external brickwork is mainly sound, but suffering from damp where gutters are missing.

As part of the future conversion of the building, an insulated inner skin will have to be provided to external walls. Also, future conversion will probably require additional window openings. Meanwhile, there is no need to replace existing doors and windows, which have the merit of maintaining plenty of ventilation to keep damp at bay.

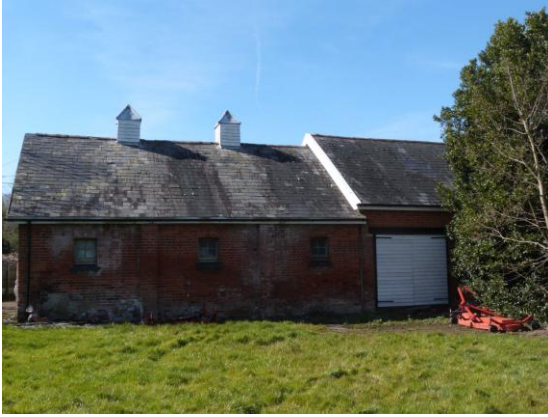
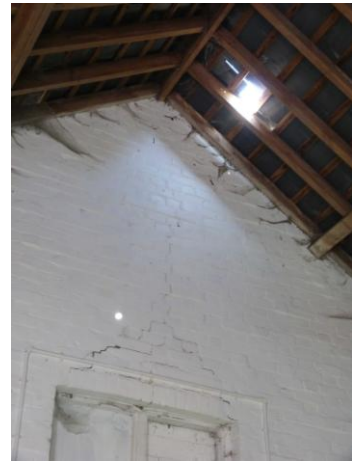
The stable building is of more recent date than the byre and has been in more recent use, so is in better condition structurally. Brickwork is generally sound, but suffering from rising damp, so a damp proof course should be installed. The slate roof has holes in some places, and recently an area on the east slope of the south wing had to be replaced wholesale, but not before a number of rafters had rotted. Otherwise roof timbers are in good condition.

The rotten rafters should be replaced and all the slate roofs replaced on sarking felt, and possibly roof-plane insulation. The recent bargeboards and fascias require soffits to be fitted, but it should be ensured that ventilation is not blocked. As with the byre, an internal inner skin will be required to external walls as part of any future conversion, and additional doors and windows may be required. It would probably be possible to insert an upper floor in the south wing and linking block, lit by dormers, but unlikely in the west wing which is narrower and has less roof space.
