HULLETTS FARMHOUSE,
PILGRIMS HATCH, BRENTWOOD
WORKS REQUIRED TO HISTORIC
BUILDING

ALAN STONES AADip TPDip IHBC ret

March 2016

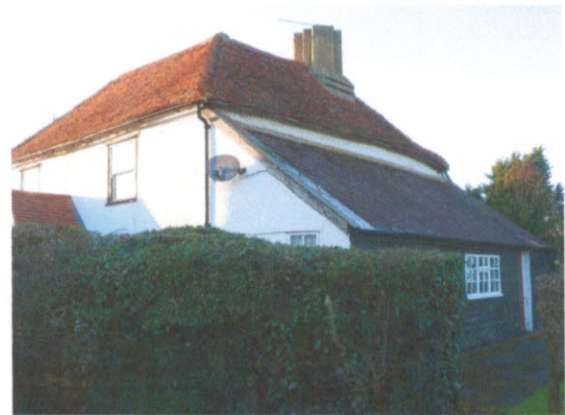
Central six-shafted chimney stack

A major source of damp is the central chimney stack in the fifteenth-century wing. The six shafts above the roof level have been cement rendered, and there appears to be no flashing onto the roof tiles. The cement render should be carefully removed, and the stack repaired and restored to its original appearance using soft red, Tudor-size bricks where bricks need replacement, and lime mortar. The stack should then be lead-flashed on to the roof tiles. The second chimney stack should also be repointed in lime mortar and lead-flashed on to the roof and walls.

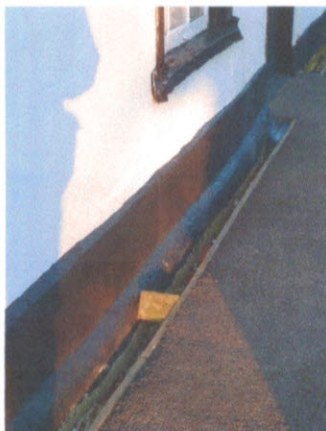
There are signs of damp in a number of locations around the perimeter of the building, due to the brick plinth being below external ground level.

Gully formed in attempt to keep damp from brick plinth

The existing tarmac path around the building should be removed and the ground level reduced by at least 150mm. Any replacement path should be kept at least 1m from the building and the intervening space filled with a french drain backfilled with shingle, the drain pipe to be slightly below the level of the plinth footing, but not so close as to undermine it. A paving slab should be loosely laid in the shingle in front of each external door. Rendering should be removed from the plinths, and the brickwork repaired using lime mortar, and any replacement bricks to be soft reds. At the same time the sole plate of the timber frame should be checked for rot, and if necessary any decayed sections should be replaced in new, seasoned oak. The lime rendering to the external walls appears largely intact, though there are localised cracks and spalling. Any masonry paint should be removed and decayed render raked out. These areas should then be filled with lime plaster and the whole wall surface skimmed and lime-washed.

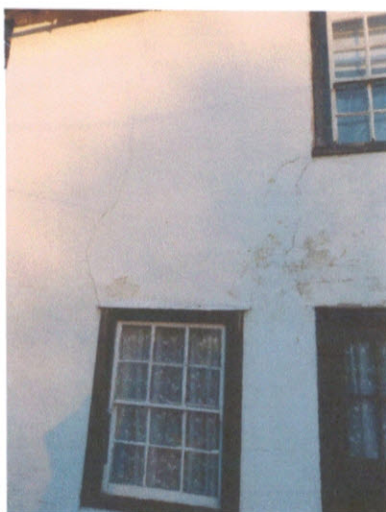
Surface deterioration of lime render

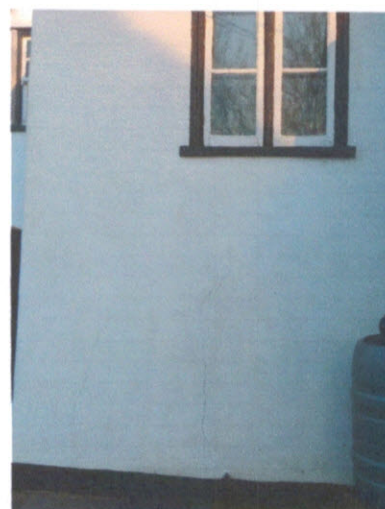
Cement render on stair tower

There are also signs of damp within the stair tower and adjacent to the second chimney stack. The recently applied cement render and lathing should be removed and replaced by lime render on split-chestnut lathing. The weatherboarding and the painted brickwork to the outshot appear sound and can be left.

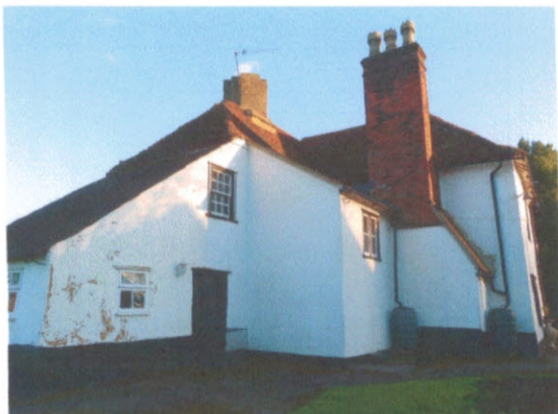
should be replaced with secondhand pegtiles. The roof of the stair tower, recently re-clad in machine-made clay tiles, is too shallow in pitch for clay tiles to work effectively, and should be re-covered in Welsh slates. Insulation and sarking felt should be checked and upgraded if necessary. The bitumen felt tiles should be removed from the lean-to and outshot roofs and replaced by Welsh slates, taking the opportunity to insert sarking felt and upgrade insulation.

Shallow pitch of stair tower roof

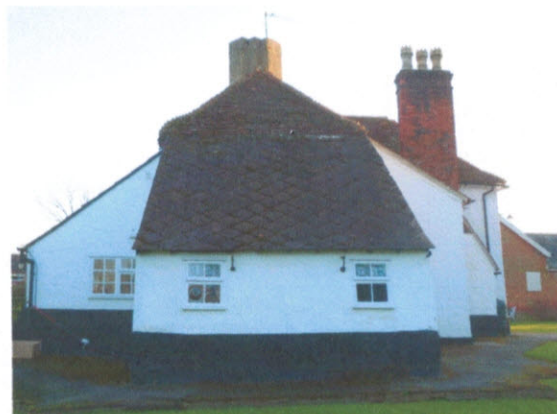
Lean-to roof and missing gutter

Gutters and downpipes appear to be intact and functioning, apart from the lean-to, where the gutter and downpipe are missing, though the gutter brackets and bottom down-pipe connection are still in place. These should be reinstated.

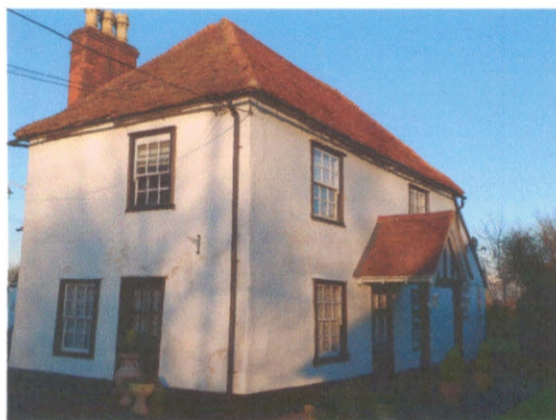
Sash windows to be repaired

Sash windows, and the stair tower casement, should be stripped of paint and carefully repaired to full functioning condition. Any rotten sections of frame, cill or surround should be cut out and new wood of identical profile pieced in. Existing glass should as far as possible be retained. Twentieth-century windows should also be retained and repaired or, if preferred, the casements and top lights may be replaced by larger paned casements simply divided at the mid point, similar to the stair tower window.

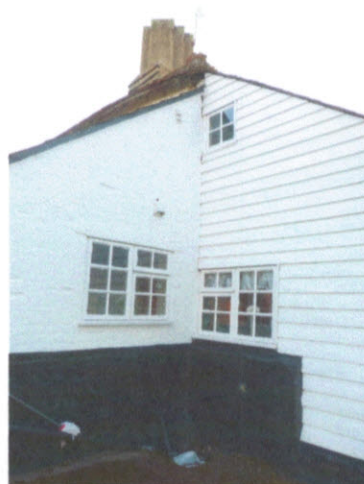
20th century windows to be repaired or replaced

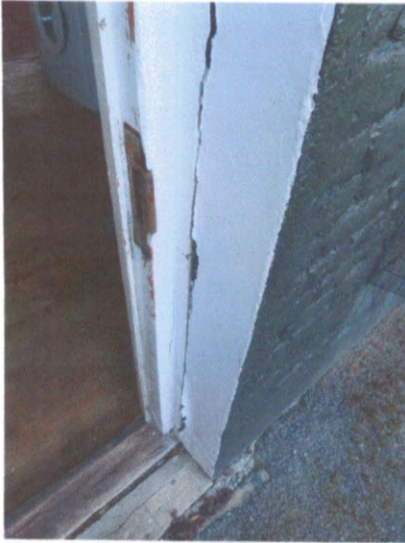
Kitchen door in outshot

When the ground level has been reduced, the opportunity should be taken of repairing or replacing the cills of external doors and providing water bars and draft proofing. Some making good is required around the frame of the kitchen door in the outshot and the front door on the south elevation. Apart from that, all external doors should be retained.

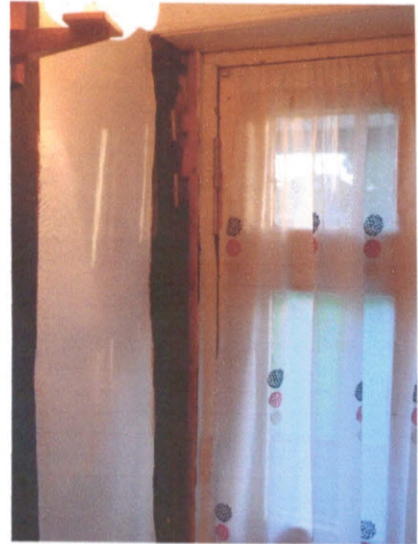
Front door on south elevation

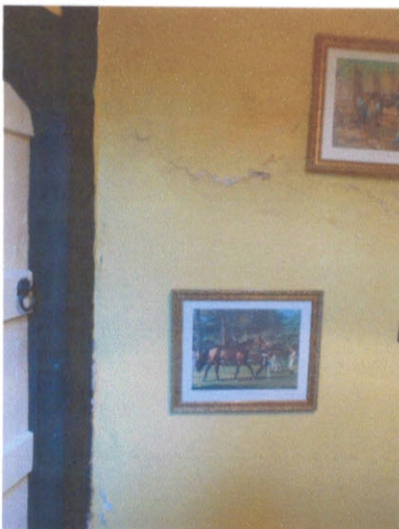
Damp plaster on main chimney breast

Once the chimney stacks have been repaired and the external ground level lowered, and the walls allowed to dry out, defective plasterwork should be hacked off from previous damp patches and repaired in lime plaster.

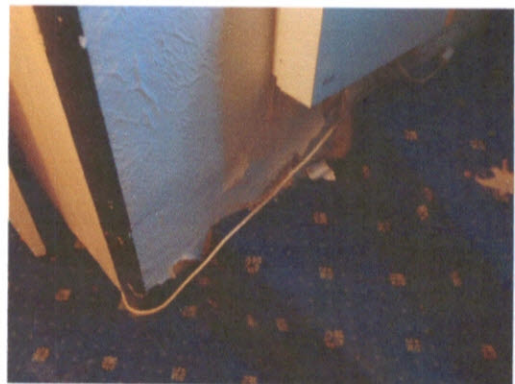
Damp plaster on second chimney breast

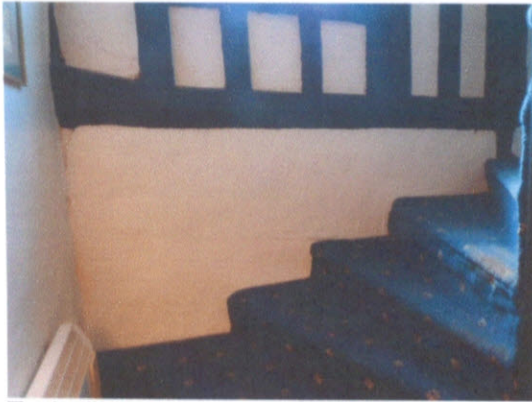
Typical black-painted timbers in stair tower

Wallpaper and ceiling paper should be stripped off to check the condition of the plaster underneath and make good where necessary. The Artex and plasterboard ceiling over the stair tower should be removed, insulated and replaced with lime plaster on laths. The black paint on exposed timbers should be completely removed with chemical poultice and scrubbing brush and the surface treated with beeswax.

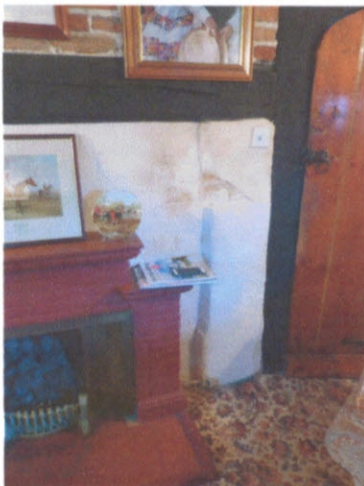
Fireplace in rear living room to be opened up – note damp chimney breast

Most of the fireplaces are attractive and should be retained. These should be checked to ensure they function safely and that there are no leaks. However, the fireplace in the rear living room in the lean-to should be removed and the original fireplace behind opened up to bressumer level, and the brickwork made good. The artificial stone fireplace in the front living room should be removed and replaced by a fireplace similar to that in the front dining room.

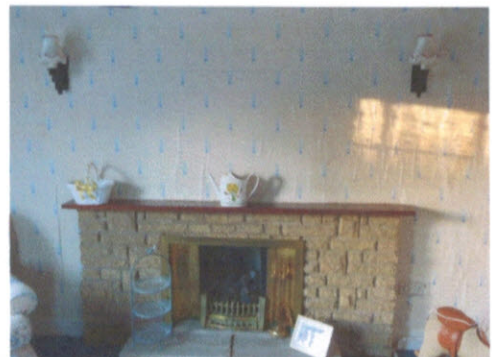
Fireplace in front living room to be replaced – note damp chimney breast
