OUTBUILDINGS AT HULLETT'S FARM, PILGRIMS HATCH, BRENTWOOD

WORKS REQUIRED TO HISTORIC BUILDINGS

ALAN STONES AADip TPDip IHBC ret

March 2016

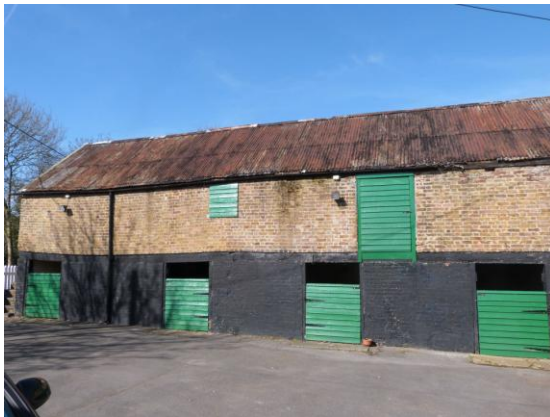
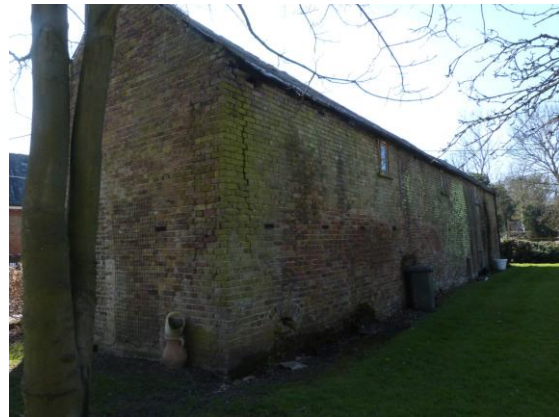
1. 18th CENTURY BYRE AND HAYLOFT

This is a long, narrow, two-storey building of 230mm yellow stock brick with a 45° pitched corrugated-iron roof. Formerly the cattle byre was on the lower storey with a hayloft above. The south elevation has five doorways giving access to the lower storey, with a continuous oak lintel, except for the fifth opening, where it has been replaced by a concrete lintel. The lower storey external brickwork has been painted with bitumen. The ground floor is slightly below ground level with a central drainage channel, and the space is divided into three by brick partitions, with one space accessed from the two left-hand doors, one from the centre door only, and one from the two right-hand doors.

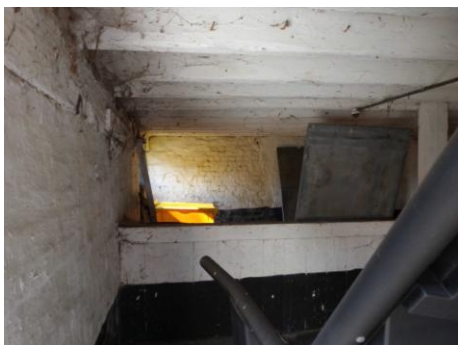
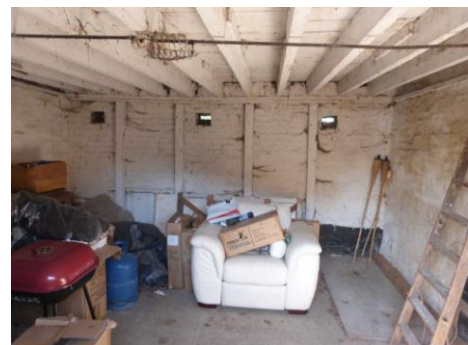
There were formerly linking doorways in each brick partition, but these have been blocked in timber studwork. Original mangers, stalls and low partitions are still in place, and there is a frequent series of vents in the north-facing external wall.

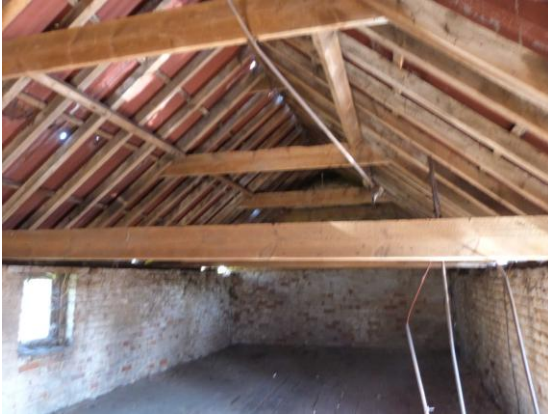
All doors are of painted weatherboarding, as are top-hung shutters to the upper-storey south elevation windows. Those on the north elevation are glazed without shutters. Ground floor doors on the south elevation are two-thirds height stable doors with the top part left open.

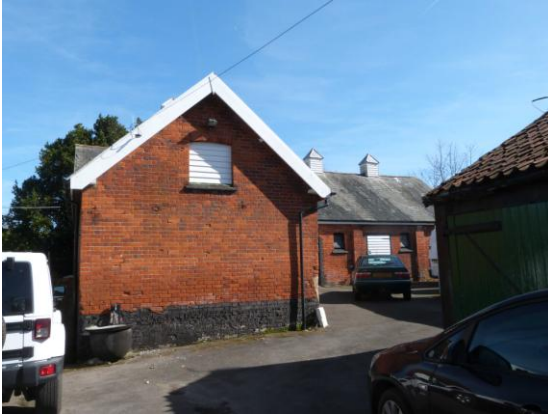
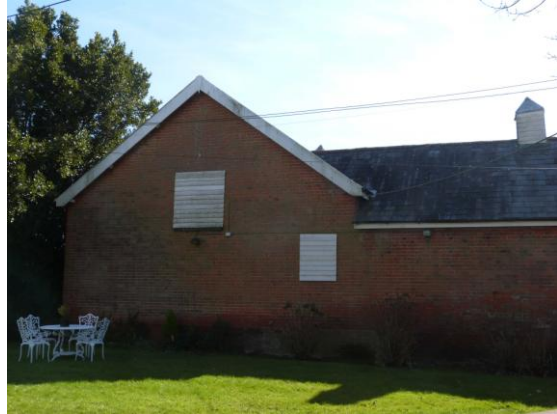
2. 19th CENTURY STABLES

The stable building is L-shaped, with two wings with lower eaves joined together by an element with higher eaves. Each is a separate internal space. The whole building is of 230mm soft red brick with 30° pitched slate roofs. The walls of the south, lower-eaves wing and the higher-eaves element are buttressed to carry roof trusses. There is no upper storey.

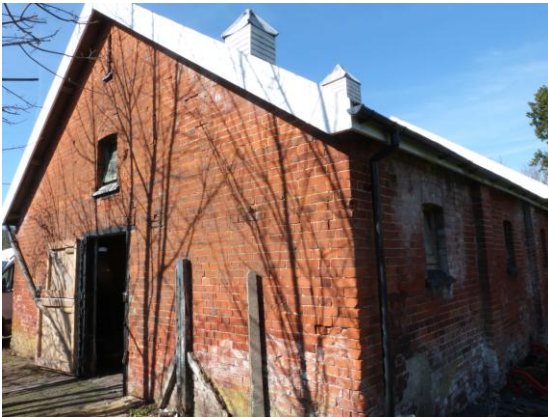
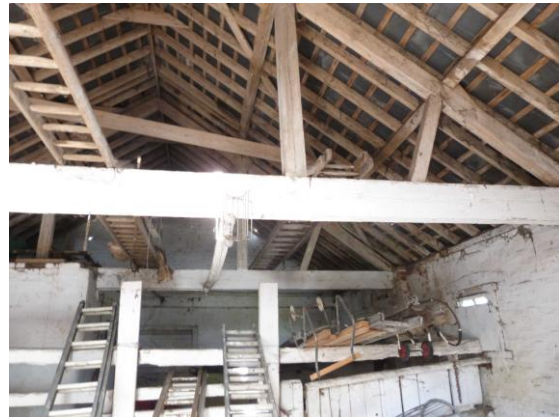
Fascias, bargeboards, gutters and downpipes have all been recently renewed, and are in good condition. Doors and window shutters where fitted are of weatherboarding.

The stable building is of more recent date than the byre and has been in more recent use, so is in better condition structurally. Brickwork is generally sound, but suffering from rising damp, so a damp proof course should be installed. The slate roof has holes in some places, and recently an area on the east slope of the south wing had to be replaced wholesale, but not before a number of rafters had rotted. Otherwise roof timbers are in good condition.

The rotten rafters should be replaced and all the slate roofs replaced on sarking felt, and possibly roof-plane insulation. The recent bargeboards and fascias require soffits to be fitted, but it should be ensured that ventilation is not blocked. As with the byre, an internal inner skin will be required to external walls as part of any future conversion, and additional doors and windows may be required. It would probably be possible to insert an upper floor in the south wing and linking block, lit by dormers, but unlikely in the west wing which is narrower and has less roof space.
