HULLETTS FARMHOUSE,
PILGRIMS HATCH, BRENTWOOD
WORKS REQUIRED TO HISTORIC
BUILDING

ALAN STONES AADip TPDip IHBC ret

March 2016

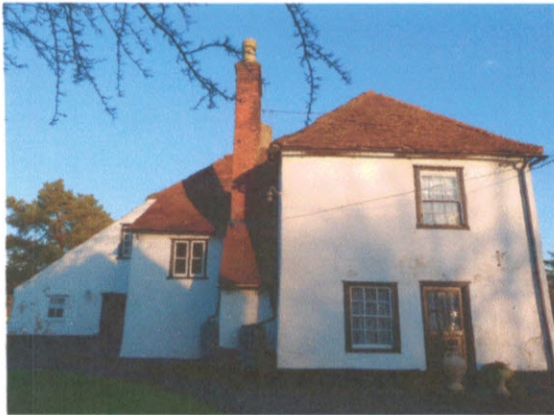
Stair tower (left) and second chimney stack

There are also signs of damp within the stair tower and adjacent to the second chimney stack. The recently applied cement render and lathing should be removed and replaced by lime render on split-chestnut lathing. The weatherboarding and the painted brickwork to the outshot appear sound and can be left.

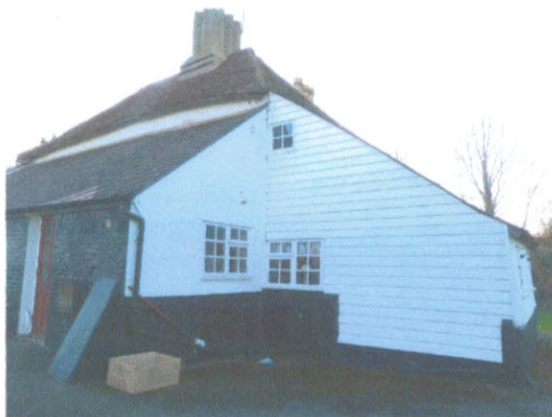
18th century lean-to extension

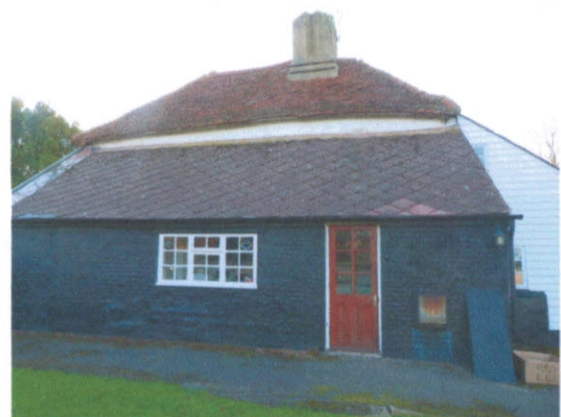
19th century brick outshot

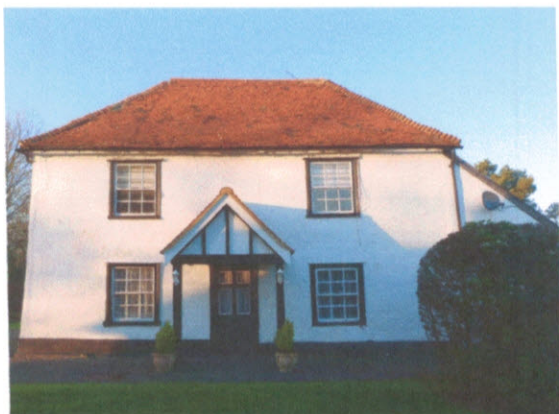
South elevation with porch and 18th century sash windows

Sash windows, and the stair tower casement, should be stripped of paint and carefully repaired to full functioning condition. Any rotten sections of frame, cill or surround should be cut out and new wood of identical profile pieced in. Existing glass should as far as possible be retained. Twentieth-century windows should also be retained and repaired or, if preferred, the casements and top lights may be replaced by larger paned casements simply divided at the mid point, similar to the stair tower window.
